CASE STUDIES: APPLIED CONDITION MONITORING

Author: Carl Andre Olsen – ConditionALL AS

Date: Updated November 2025

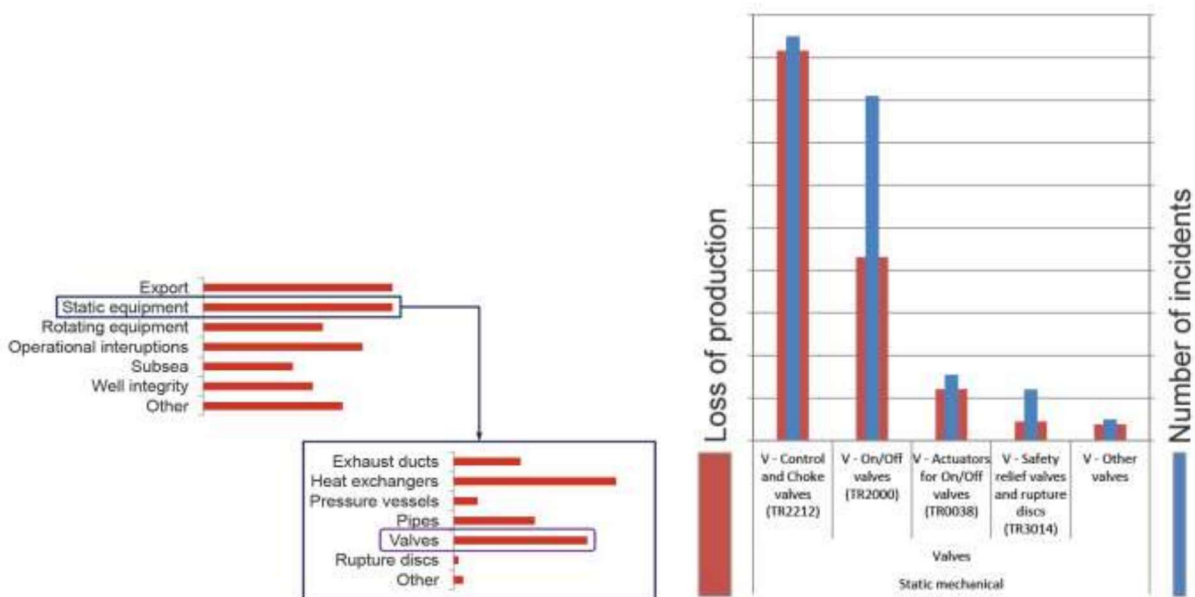
Figure 1 - Analysis of offshore equipment related to production losses (Equinor 2014)

On/off valve assemblies typically represent a major loss of production, but monitoring is not as widespread as for control valves, where lots of solutions are available.

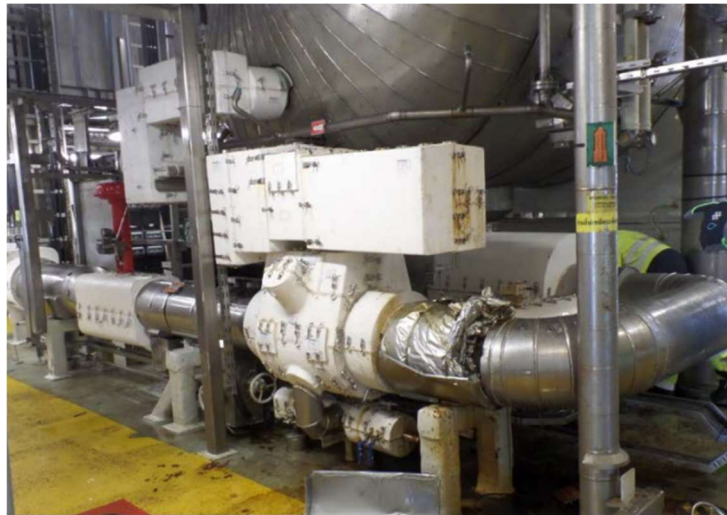
A condensate pipeline, downstream from an ESV (Emergency Shutdown Valve), bursted. Causing a leak of ca 8 kg/s for a while, because the ESV that was the isolation barrier for the separator did not close.

The ESV is a ball valve with a pneumatic, spring return actuator, fail to closed.

Figure 2 - Emergency Shutdown valve for condensate after 1st stage separator

After the incident, various components in the facility was investigated by the police and government agencies, and data from the condition monitoring system shows that the ESV had developed more and more friction for each stroke since day 1 in operation.

Condition Monitoring benefit: If the condition monitoring system alerts had been forwarded to the systems the client used, they could have handled this issue much earlier. Only using the limit switches to calculate the travel time of the valve, would not have helped in this situation. The valve was stuck at 96% and after enough air was emptied, it slammed shut in less than a second.

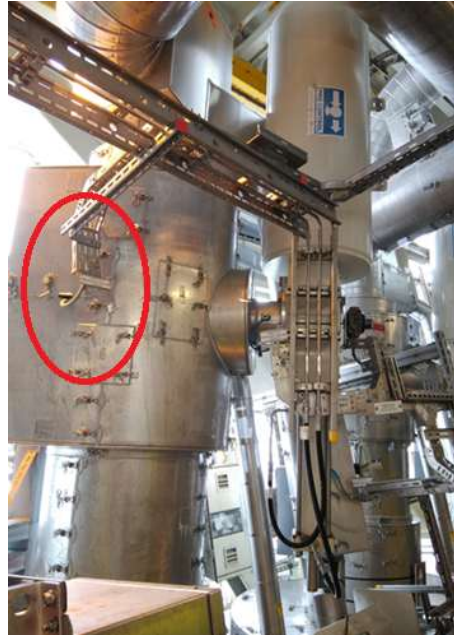
A water injection ESD (Emergency Shutdown) valve was leaking water into the oil-well while closed. This leak was detected by our **acoustic leak sensor** mounted directly on the valve body, encased in insulation. Location is inside the red circle in figure 3.

Figure 3 - Insulated water injection valve with acoustic leak sensor.

The leakage at the time of the discovery was small enough to continue production, without serious losses. If the leak had not been discovered earlier the initial leak at this pressure would lead to erosion and cavitation, that would worsen the leak exponentially, until the production would have gotten a huge hit from all the water pushed into the well.

Condition Monitoring benefits: Parts for the valve was ordered immediately after a borescope inspection had been made, verifying an issue with the valve seats. The valve was scheduled for maintenance very soon after, since the issue was developing. This issue could have caused major issues with the reservoir and production if not discovered soon enough.

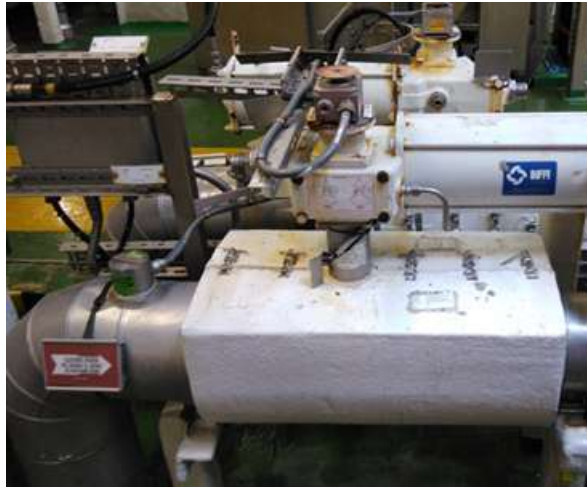
A 4 inch full bore valve with monitoring, **actuator pressure sensor**, **valve force sensor** and valve cavity **acoustic leak monitor**, had undergone maintenance during a turnaround. The instrumentation had been upgraded and the valve now closed in less than 0.3 seconds.

This causes the seats to wear down quicker than planned for, and the valve is at an increased risk of passing or increased friction.

Figure 5 – The 4 inch ball valve closing much faster than both seats and stem is designed for

Because of logic delays and automatic functions in the DCS, this low travel time would not have been noticed by the DCS itself. After a conversation between ConditionALL and the instrument lead on the site, someone adjusted the instrument speed block so that the valve now closes in 2 seconds, reducing wear.
